*Morrone Stadium — UConn Soccer Field (Storrs, CT)*

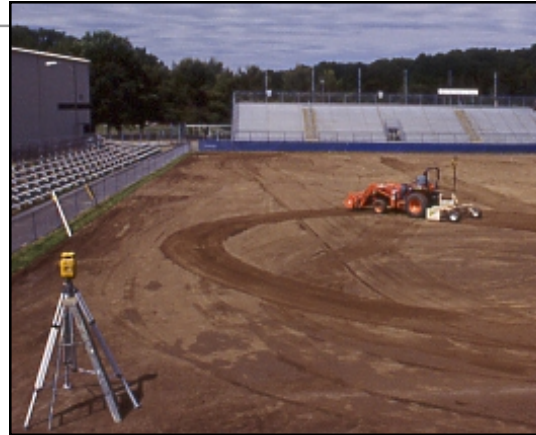
**Laser grading**

Championship Turf Services stripped the existing turf with a sodcutter, adjusted the soil's pH, then cultivated the ground. We then laser leveled the field for dual diagonal slope. Sodding was completed on July 1, and play commenced on August 18. A national championship for UConn soon followed.

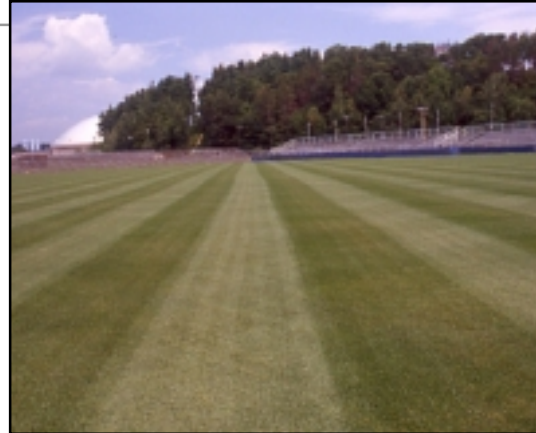
**Ready for play**
